Paper machine: Bearing failure

- High speed paper machine
- System Reporter 200 with software version 5

This case study demonstrates a bearing failure in the second of eight dryers in a modern high-speed paper machine.

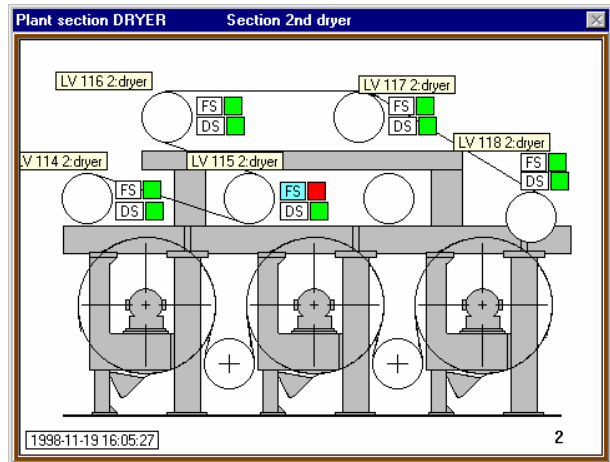
Figure 1. Tree.

The error is indicated in red in the System Reporter tree (Figure 1) and the problem can be addressed to the section 2nd dryer. The section overview Figure 2) points out that the accelerometer mounted on the front side (FS; opposite the drive side, DS, where the engine is connected) on roll LV115 triggered the alarm.

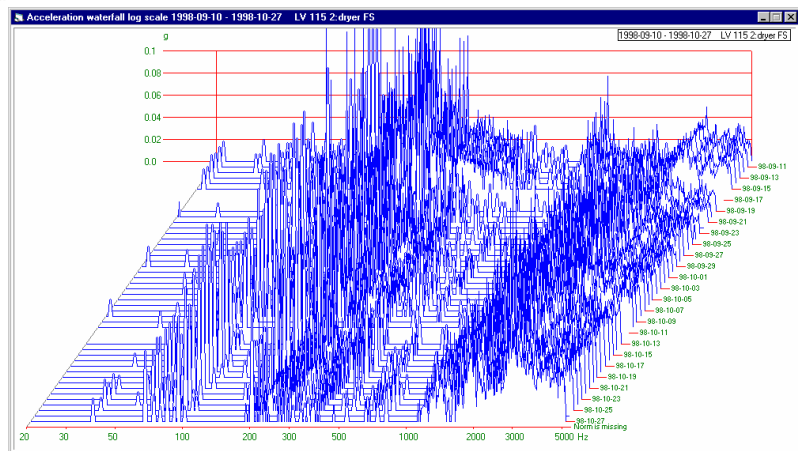
Figure 3. Waterfall spectrum.

A waterfall spectra displays an overview of frequency bands from hourly measurements clearly demonstrate that something is wrong (Figure 3).

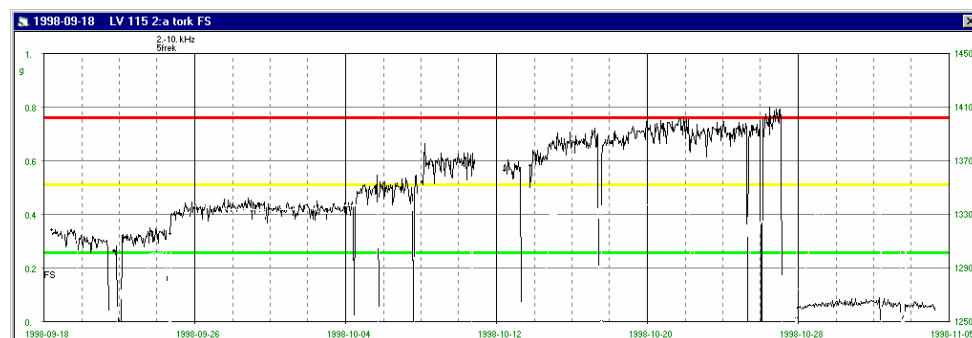
Figure 4. RMS trend for 2 – 10 kHz.

Figure 4 shows the RMS trend for the frequency range 2 to 10 kHz. The trend ranges from September 18 to November 5, 1998. During this period of time the output signal from the accelerometer increases from 0.3 g to 0.8 g (the low levels at the end of the time period demonstrates the signal after the problem was solved). As the low alarm level was set to approximately 0.5 g (yellow line) and the high alarm level to 0.75 g (red line), the alarms were triggered in early and late October

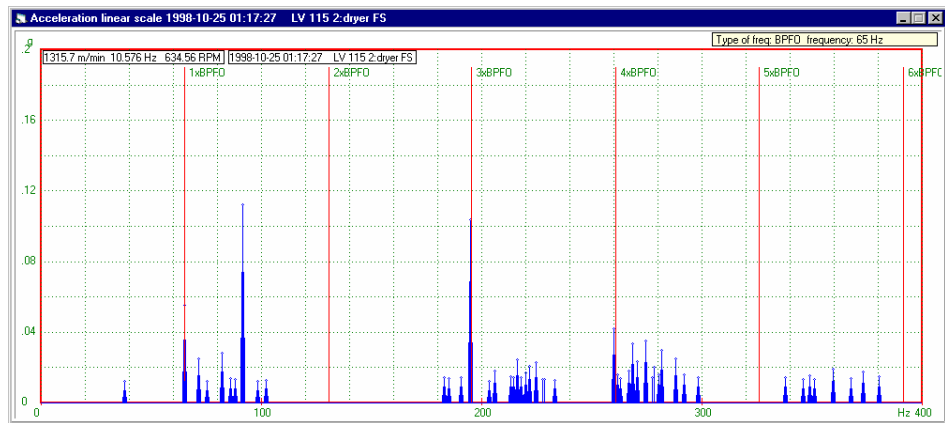
Figure 5. Single spectrum after automatic frequency analysis.

The results from the automatic frequency analysis are shown in Figure 5. System Reporter has identified that the error has frequencies similar to harmonics originating from BPF0 (ball pass frequency, outer) errors, i.e. that the error originates from a defect outer ring in a bearing.

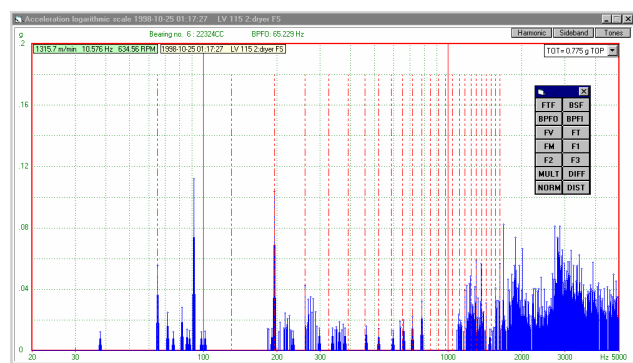
Figure 7. Single spectrum with BPF0 harmonics.

The analysis can also be performed manually. by using the toolbox (see Figure 6). In Figure 7, the harmonics for BPF0 has been selected in the toolbox. At approximately 65 Hz, 195 Hz and 260 Hz, frequencies that coincide with the known harmonics of an error caused by a defect outer ring in a bearing are found.

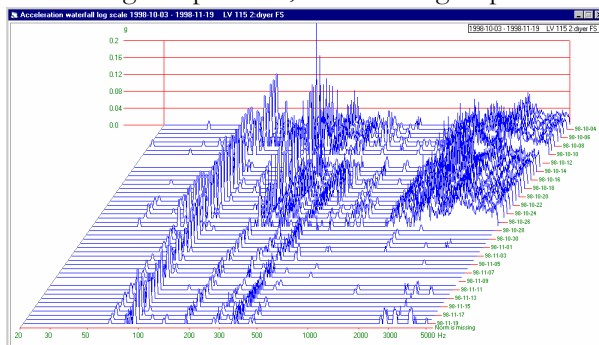
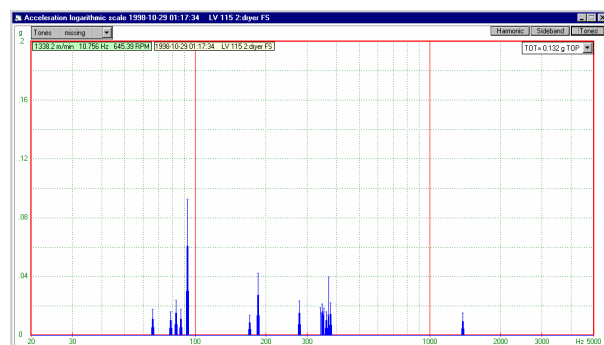
Figure 8. Waterfall spectra before and after replacing the bearing (left) and single spectrum after replacing the bearing (right).

The last picture (Figure 8) shows spectra from the unit after the problem as solved, i.e. the bearing was replaced by a new one. The waterfall spectrum shows the output signal (the accelerometer) before and after addressing the problem, and the single spectrum

shows that the cluster of peaks above 1 kHz has disappeared.
