Paper machine: Defective lubrication unit

- High speed paper machine
- System Reporter 200 with software version 3

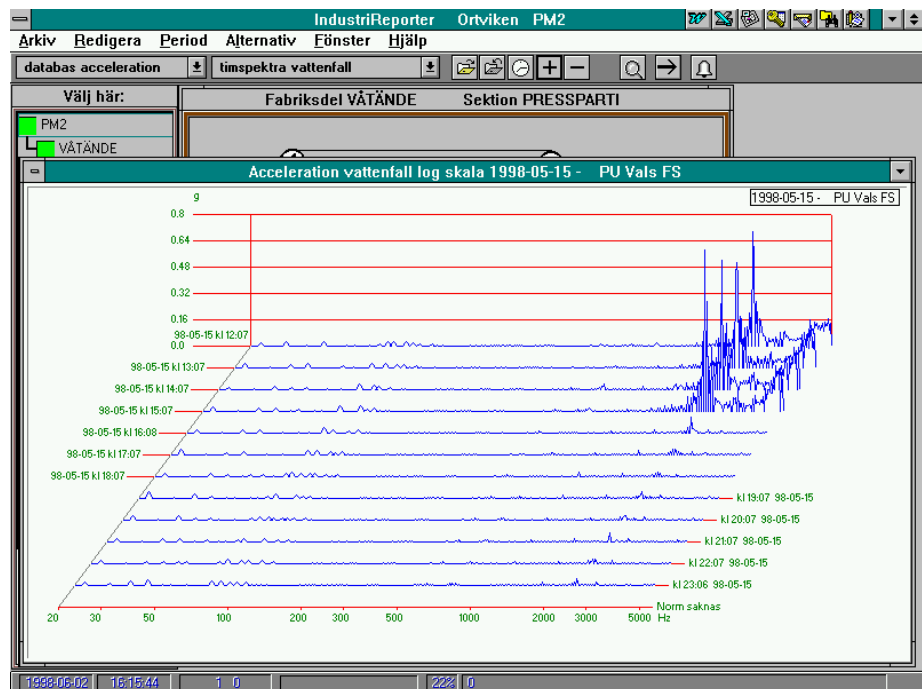
Figure 1. Waterfall spectra from 12⁰⁷ to 23⁰⁶ on May 15, 1998.

Figure 1 shows a waterfall spectra with high frequency vibrations above 2 kHz, taken from a PU roll (pick up roll) in the press section of a paper machine (see Figure 2). The rolls have one bearing at each end, which are lubricated by oil from a central lubrication unit. The high-frequency vibrations occurred when the path from the central lubrication unit was blocked and no oil came through. Somewhere between 15:07 and 16:08, oil was added to the sys-

tem. As a result, the cluster of peaks above 2 kHz disappeared.
