Paper machine: Bearing failure

- The case study presented in this document demonstrates some of the powerful analysis tools available in System Reporter
- High speed paper machine
- System Reporter 200 with software version 5

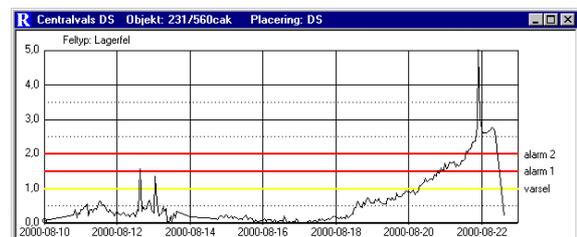
Figure 1. SPADE trend showing that bearing related frequencies increase to reach above high alarm levels above within four days.

This study shows how the SPADE expert system works. For the current application the SPADE expert system was configured to filter out all frequencies originating from bearings, e.g. BPFO, BPFI, BSF, FTV, and to summarize these in combination with some 50 overtones into a total bearing error (“Lagerfel” in Figure 1). Figure 1 shows a trend of the SPADE total bearing error

on bearing 232/560cak located on the drive side of the central roll in the press section.

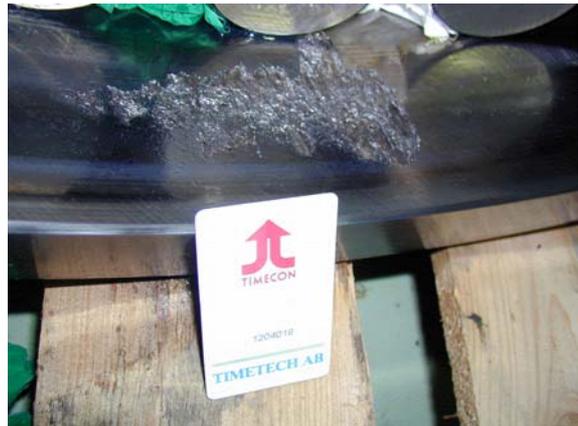
Figure 8. A damage in the bearing outer ring approximately 120 × 60 mm. Rust damage was present on rolls and on the outer ring, indicating that water has entered the bearing casing.

Based on the alarms and analysis results generated by System Reporter, it was decided to stop the paper machine and replace the faulty bearing (see Figure 8). If the error would have been left unattended, a breakdown would most probably have occurred, with associated costs in the range of millions US \$.

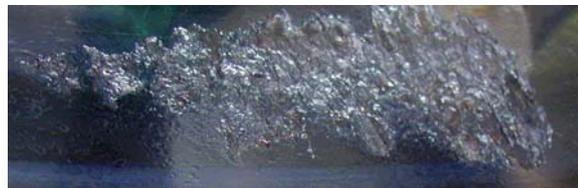
Figure 9. Zoomed-in view of the damage shown in Figure 8.
